D1: ESTABLISH TEAMS

D2: PROBLEM DESCRIPTION

Describe: Customer (Intelligent) (A) Found abnormal mark on the back side of LED's substrate. (B) Found that after SMT half of the LED is brighter than the other half on the board.

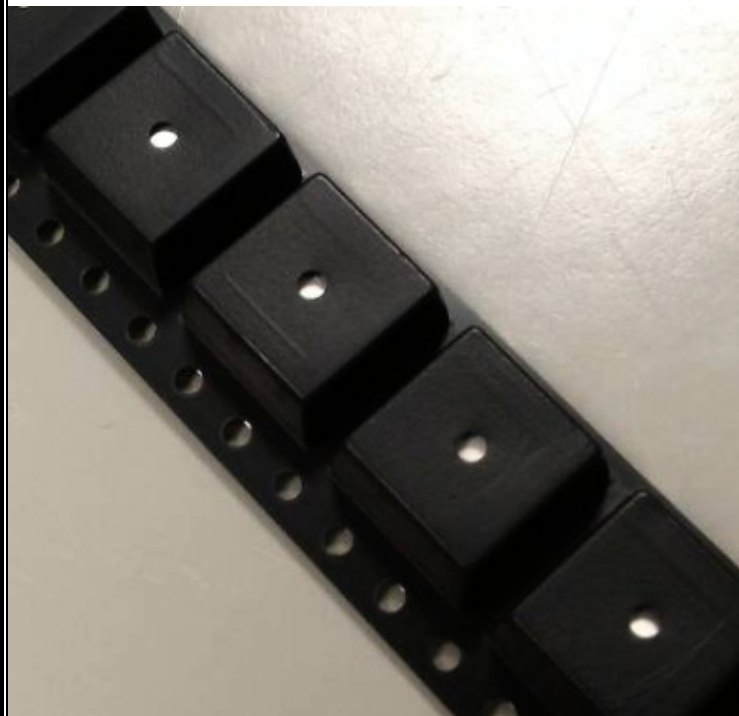
We don't have customer specification in inventory, but we also checked other T9090U-UNL1-A1GC1H samples, we didn't found same situation (back side black color problem) in our side. Please refer images as attached.

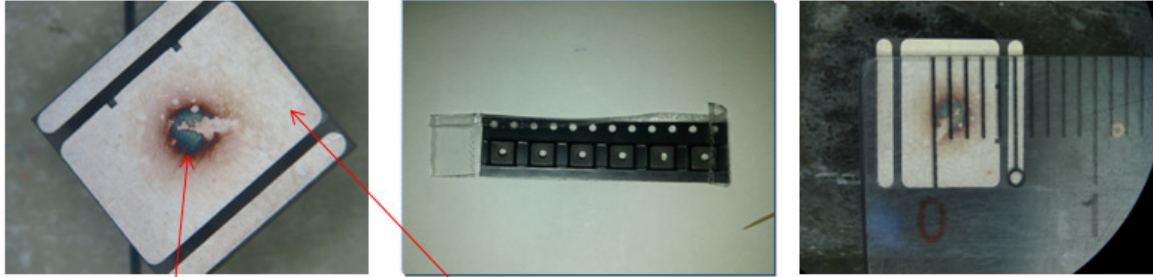
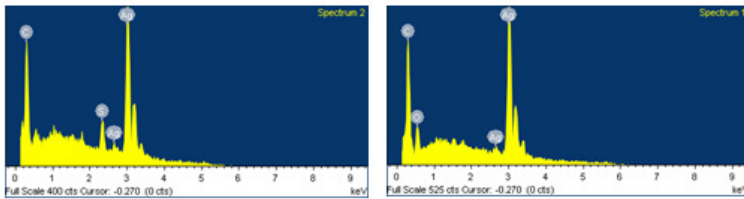
1. Found abnormal mark on the backside of LED's substrate:

Element	Weight%	Atomic%
C K	11.89	51.83
S K	4.73	7.71
Ag L	83.38	40.46
Totals	100.00

Element	Weight%	Atomic%
C K	10.51	40.43
O K	8.64	24.95
Ag L	80.85	34.62
Totals	100.00

We did EDX analysis for the abnormal mark, and it is silver sulfide. Please refer to the picture above. The size of abnormal mark is around 1.5mm to 2mm in the center of emitter, that is similar to the hole of reel bottom (the dimension is 1.5mm). We believe the abnormal mark is caused by contamination by silver sulfide during the delivery or storage environment.

Issue 1: That is caused by contamination of sulfide during the delivery or storage environment.

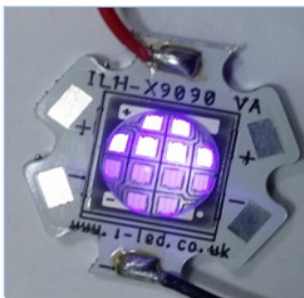
2. Found that after SMT half of the LED is brighter than the other half on the boards:

Issue 2: There were two different type chips in the package. That is caused by misoperation, operators use the wrong chip for these products.

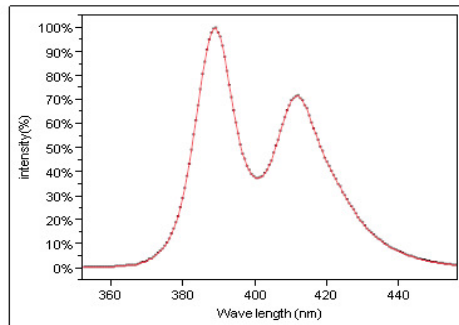
The emitter situation with 1mA driving

After checking the spectrum from IS, there were two different types of chips in the emitter, and it can be distinguished by the bond pad direction.
